Hierarchical Inspection System Using Visual and Mfl Probe Robots

ABSTRACT

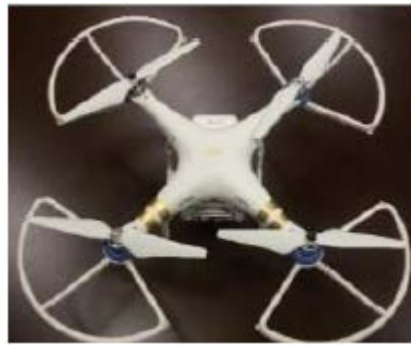
Figure 1. Phantom Pro III UAV used in this work for VBI part

For the VBI system, the images can be obtained by any means possible as long as the images are obtained with fixed initial reference positions for appropriate registration of successive images. Hence, images can be obtained from static cameras located at pre-defined places [14], or they can be movable [15]. Since the target of this work is related to a perpendicular image scan of the structure in order to develop the best surface scan, the cameras must be as perpendicular to the surface as possible. Hence, a commercially available UAV, Phantom Pro III UAV [20] as shown in Figure 1, has been used for providing the VBI component of the system with its stabilized 4K camera.

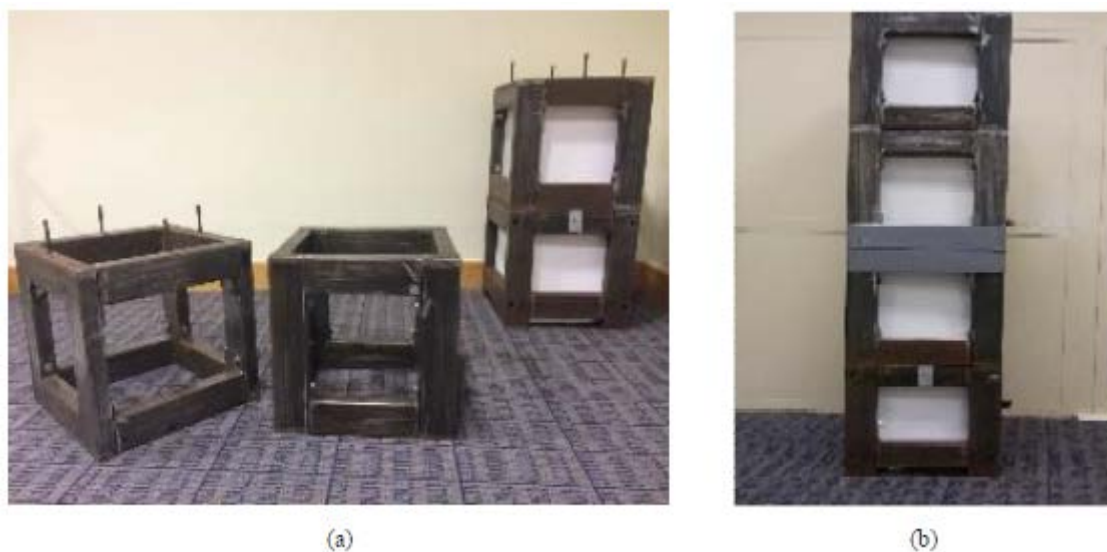
Figure 4. Structure (a) Cubical block and (b) final design

The selection of structure and the testing conditions is one of the critical tasks in the design of this SI system, since it must emulate the main challenges of the real world structures to as greater degree as possible. A test structure was built for performing various initial tests in the laboratory. The structure consists of four homogenous metallic cubes placed sequentially on top of each other, as shown in Figure 4.

The reason of selecting such a structure is to ensure that the conclusions obtained from this research address most of the typical civil structure problems without being loaded down with other uncertainties or scaling factors. Several experiments were in this environment in such a manner that the parameters modified by the environment, e.g., wind, camera drifts or zooming issues etc. can be avoided at first and then added in a controlled manner to test the limits of operation of the system.
